PRODUCT UPDATE BULLETIN

PUB-TX3-014

TX3 VOICE ENTRY, CARD ACCESS AND ELEVATOR RESTRICTION SOFTWARE

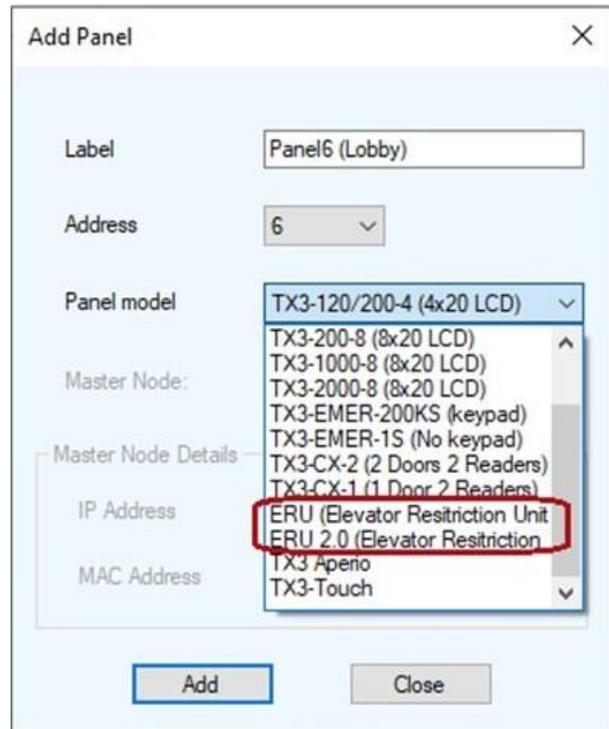
When you add a new control panel in a TX3 Configurator v2.12.12 or higher, 2 Elevator Restriction Units (ERU & ERU2.0) can be found. The 2 ERUs can be identified using the table below –

Model Number	Configurator Panel Name	Main Board
TX3-ER-8-A	ERU	MD-1094
TX3-ER-8-B	ERU 2.0	MD-1323

Both ERU and ERU2.0 can work together; however, ERU2.0 has some feature advantages that are listed below -

- You can add up to 6 TX3-ER-8(-A) Elevator Restriction Units (ERU) to a job, and up to 16 TX3-ER-8-B (ERU 2.0) to a job. You can add a combination of TX3-ER-8-A (ERU) and TX3-ER-8-B (ERU 2.0) Elevator Restriction Units in a job. The maximum number of Elevator Restriction Units in a job is 16.
- With TX3-ER-8(-A) (ERU), a maximum of 24 relays can be activated simultaneously. With TX3-ER-8-B (ERU 2.0), a maximum of 96 relays can be activated simultaneously (using Floor Groups)
- Individual relay schedules work only with TX3-ER-8-B (ERU 2.0)
